SWIVEL SNAPHOOK INSPECTION NOTIFICATION

Inspection notice for GFP products featuring a possible unsafe condition due to a supplier defect in a specific style of swivel snaphook supplied to Guardian between 8/26/2011 and 6/25/2012

Date: 6/26/2012

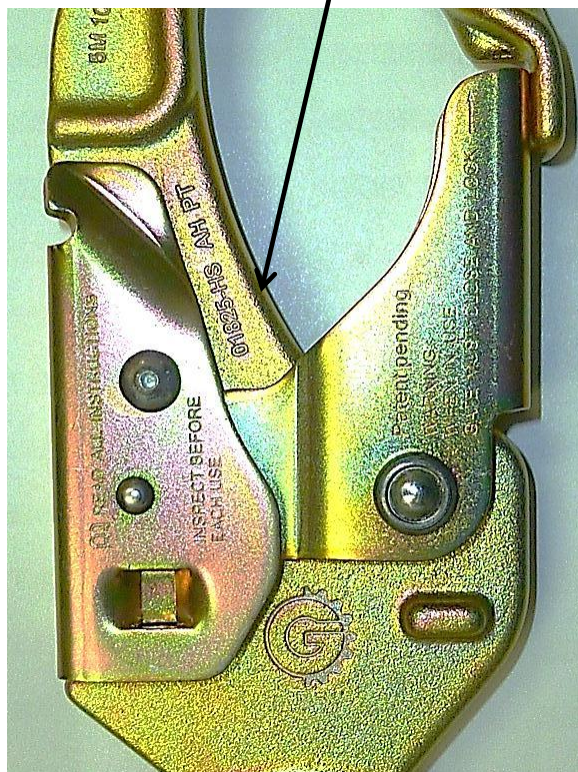
Marked with part # 01825-HS or 01826-HS on the hook body

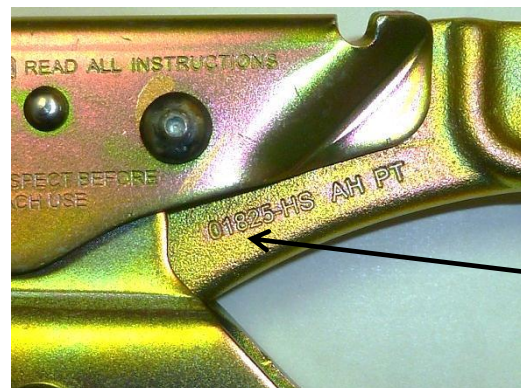
Marked with part # 01825-HS or 01826-HS on the hook body

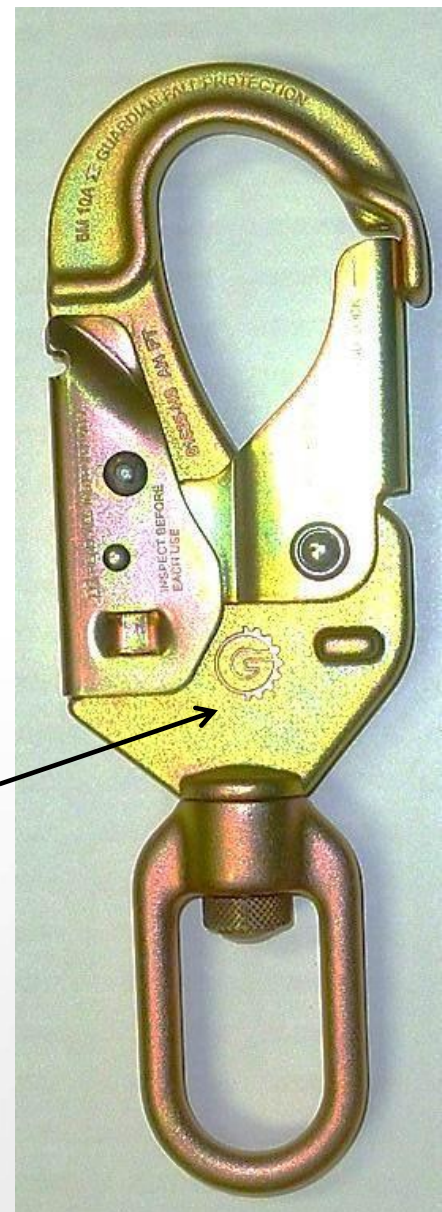
Full photo of the potentially defective swivel snaphook.

Marked with Guardian logo at hook base

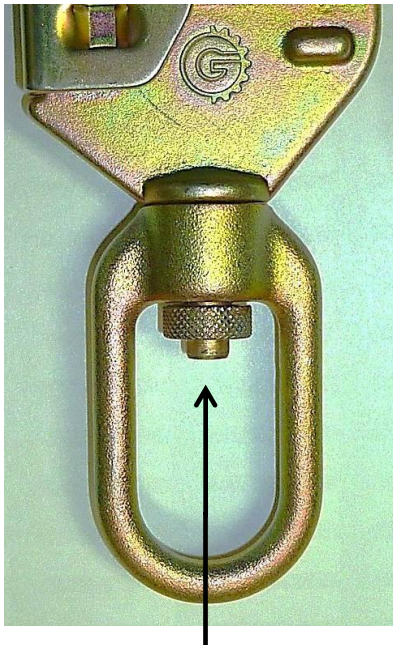
DEFECTIVE CONDITION

The potentially dangerous and faulty condition was caused when GFP's supplier of a particular swivel snaphook missed a swaging operation that encapsulates the swivel eye and prevents the threaded nut from backing off of the hook stem. This situation is restricted to a certain type of swivel snaphook supplied to GFP and is identified in this notice. Upon discovery, both GFP and the supplier have increased inspection processes to ensure this cannot occur in the future. Supplier and GFP inventories have been inspected for this condition upon discovery. **No defective units were found in inventory.** Any products you receive after June 26th have been 100% inspected specifically for this condition and any other defect.

BAD HOOK. STEM PROTRUDES STRAIGHT THROUGH THE NUT. STEM HAS NO MUSHROOM SHAPE FLARED OVER THE NUT. NUT CAN BACK OFF THREADED STEM.

Remove the product from service immediately.

Contact Customer Service at GFP (800-466-6385) to be assigned a unique RQC- return number. Guardian will provide shipping instructions for returning products and coordinating replacements for units that have the defective swivel snaphooks. Guardian will replace the product and cover the freight costs.

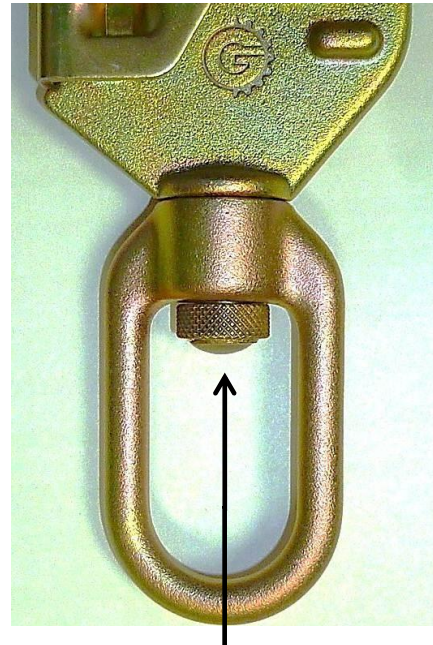
NORMAL CONDITION

NORMAL SWAGED HOOK. GOOD HOOK. STEM FLATTENED IN A MUSHROOM SHAPE. ANY SORT OF SWAGE MEANS HOOK IS GOOD. NUT CANNOT BACK OFF STEM.

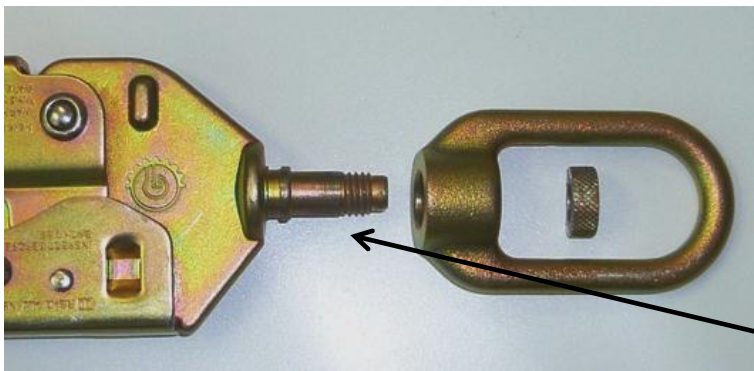
BAD HOOK. STEM OF HOOK BODY WAS NOT SWAGED OVER NUT. THREADED NUT IS CAPABLE OF SPINNING OFF THE STEM.
